**Secretariat memorandum**

**Bus staircase design**

**1 Purpose of report**

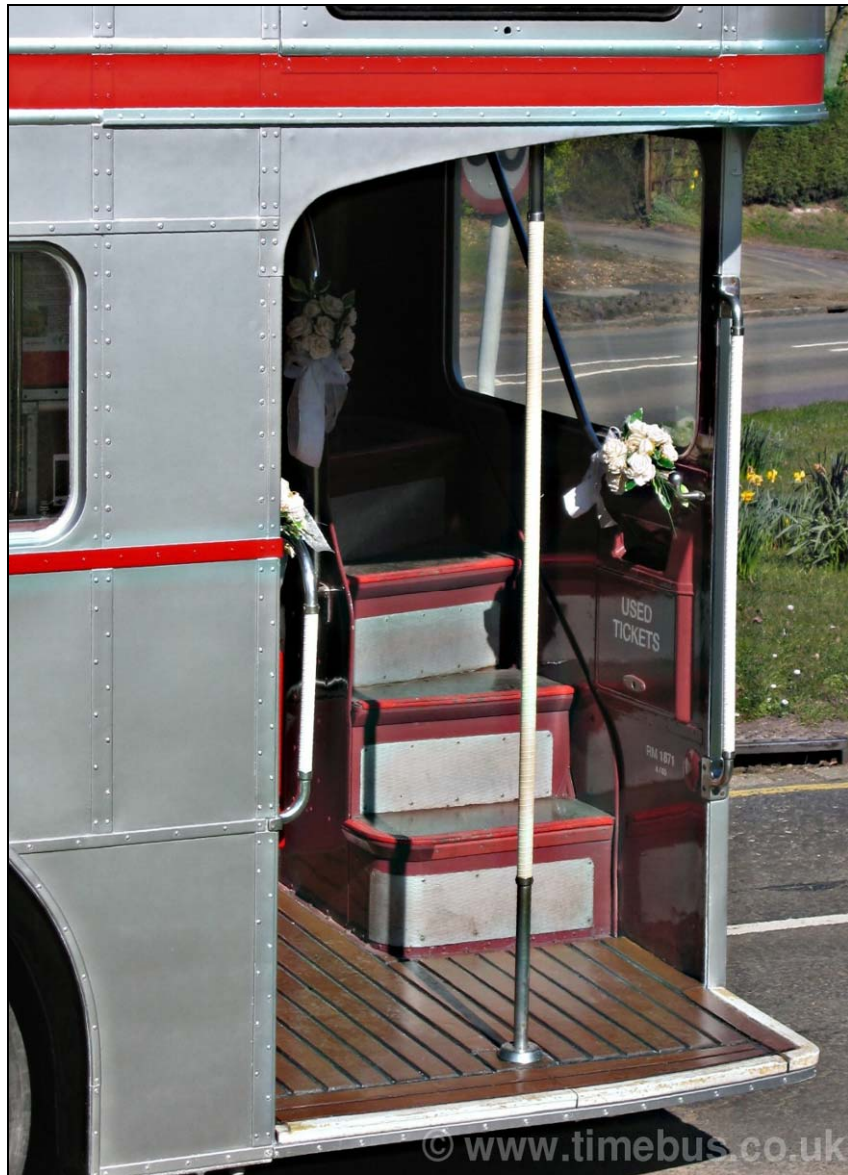
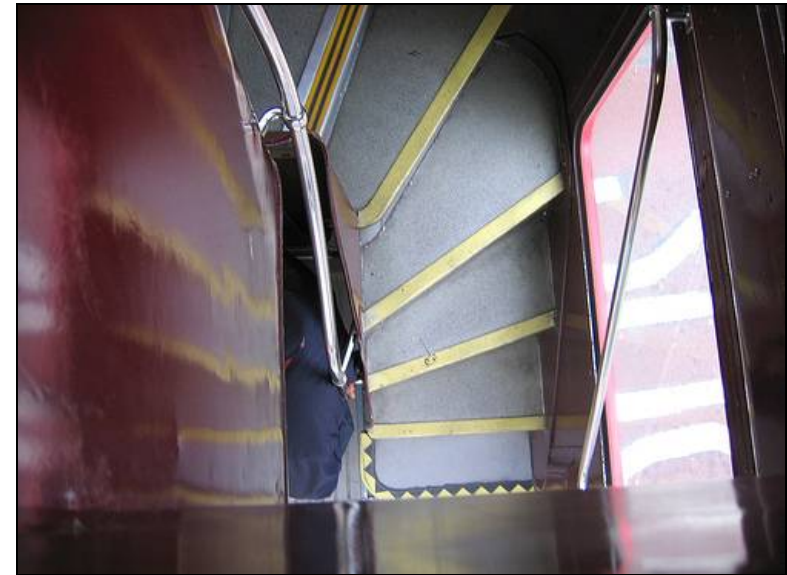
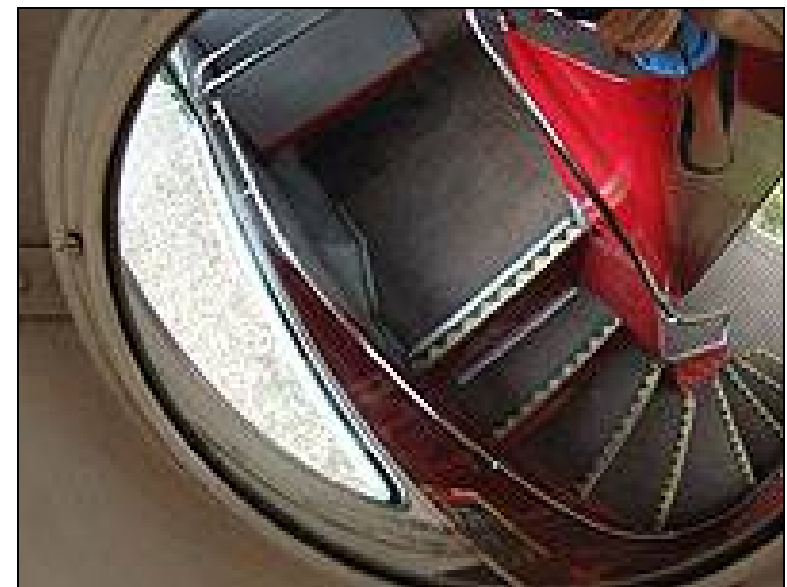
Fig 1 : Routemaster staircase

- 2.2.1 The traditional London (and British) double deck bus design was established in the 1920s. It had the engine alongside the driver at the front, and an open platform entrance/exit at the back. The staircase was in the rear offside corner, turning through 90° (Fig 1). It included a curved section where the stair treads were narrower on the inside than on the outside, but the overall design of the staircase – at least in its final incarnation on the Routemaster – was such that this feature did not seem to cause much difficulty to most passengers who were capable of climbing this steep narrow staircase at all.

- (a) All staircases should be forward ascending.
- (b) Straight staircases which present descending passengers with a long drop into an open void are not acceptable.
- (c) Of previous staircase designs in London –
  - The square staircase used on the Metrobus is the preferred option.
  - The 90° curve used on the Routemaster may be acceptable, subject to careful attention to design detail and to user testing.
  - The 180° spiral used on the DMS and the Titan is not acceptable.
- (d) If an entirely new design which embodies the safety principles implied by the foregoing is envisaged, then this can be considered. However it should only be adopted after service trials on a prototype vehicle, with success being evaluated both through passenger questionnaires and by study of CCTV images of actual passenger behaviour.

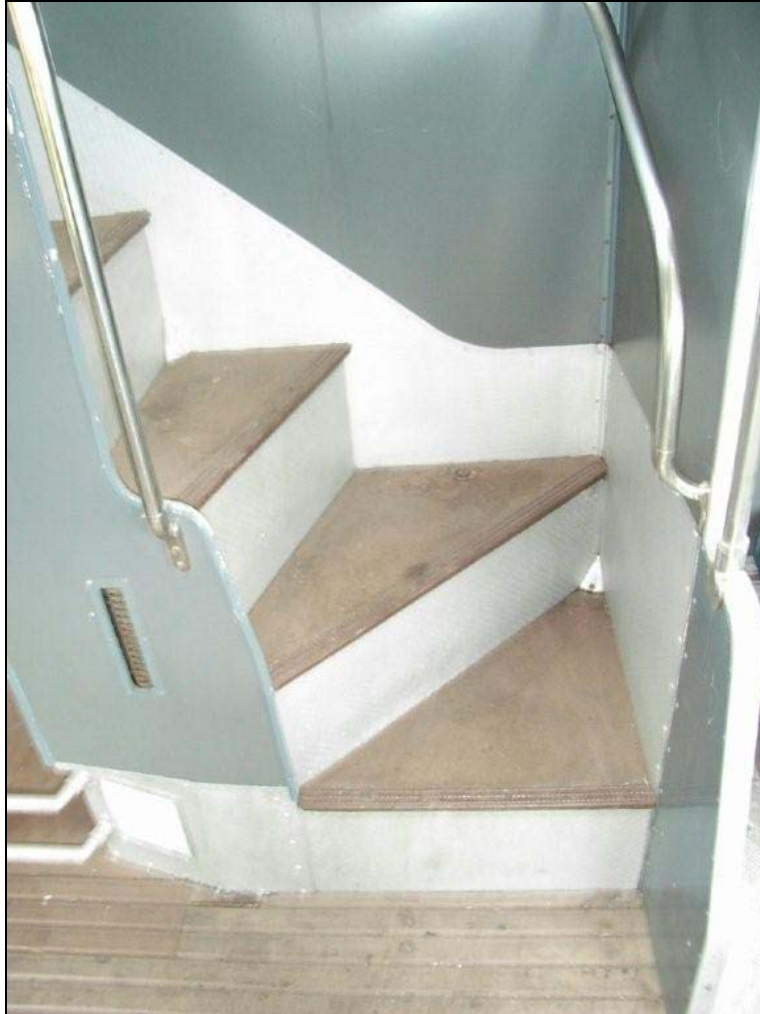
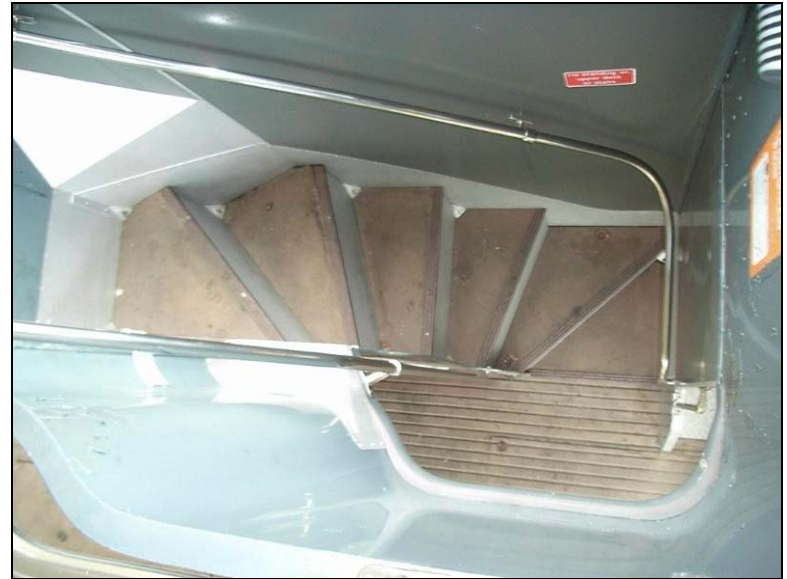
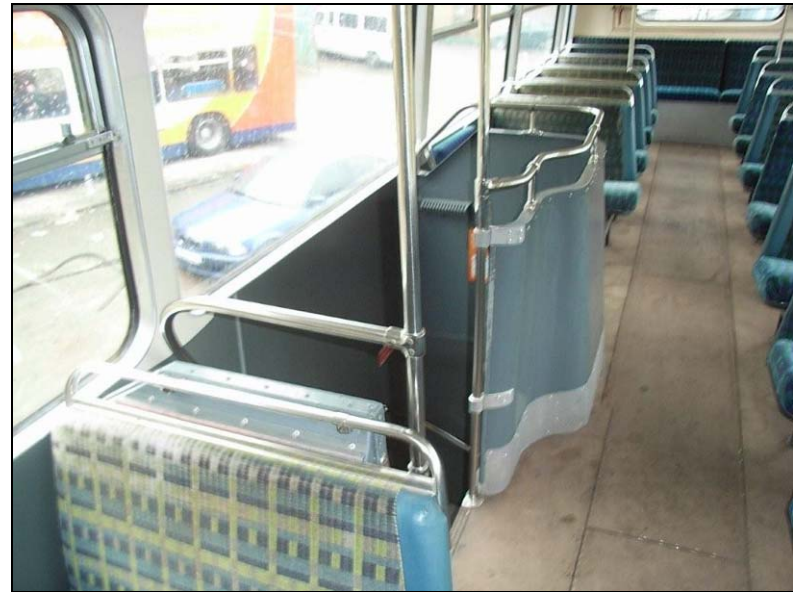
Fig 2 : DMS staircase

Despite London Transport having many reservations, economic and political forces drove it to adopt the new layout from 1970, on a bus known as the DMS or Fleetline (Fig 2). As well as the front entrance, there was a centre exit. This enabled the staircase to be placed near the centre of the bus, with its foot opposite the exit door. It was designed as a spiral turning through 180°, and its central position meant that it could be forward ascending and avoid the safety hazard of the rear ascending design.

Compared with the Routemaster, the spiral effect of stair treads being narrower on the inside seemed more severe, and it could be seen that if this feature of the DMS could be designed out it would be easier for passengers.

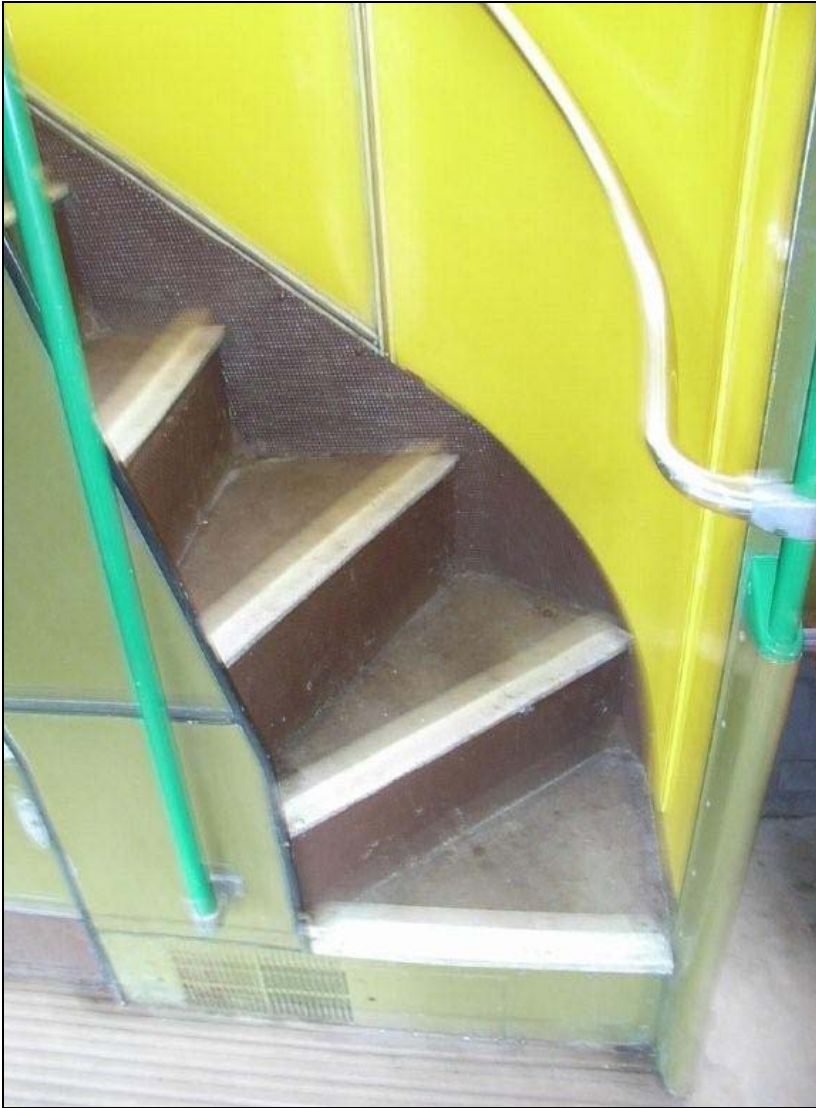
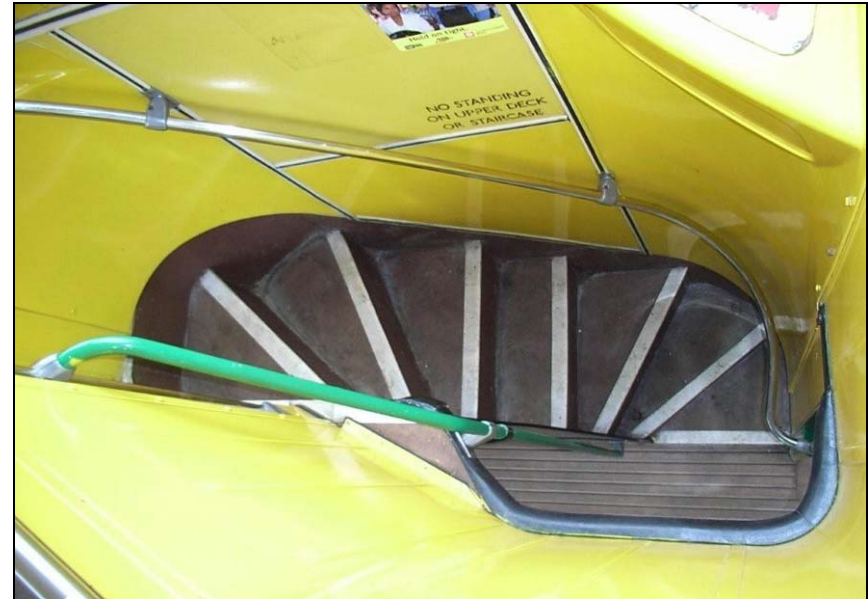
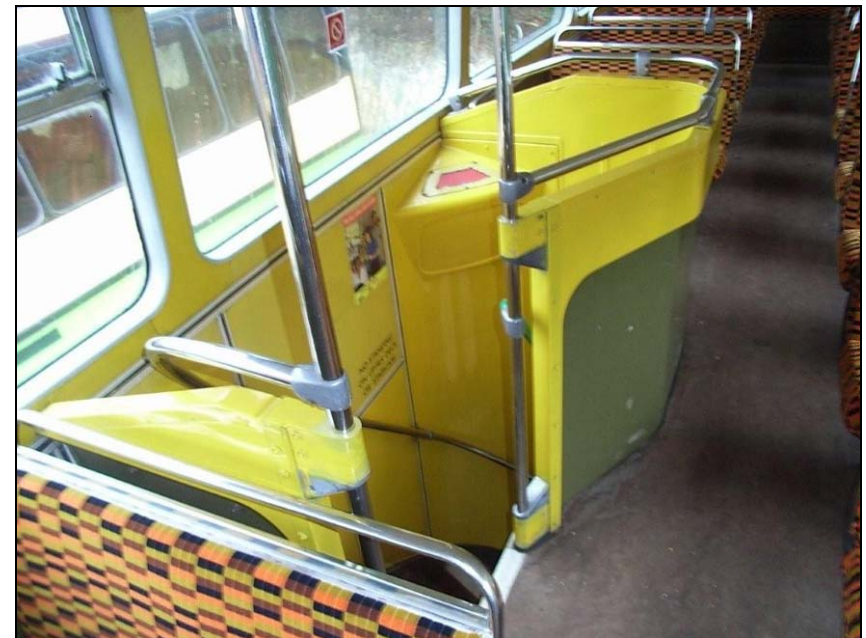
Fig 3 : Titan staircase

2.2.3 The 1980s saw London standardise on two double-deck bus designs – the Titan and the Metrobus. The Titan (fig. 3) was very similar to the DMS, although the spiral effect was (if anything) worse towards the bottom of the staircase.

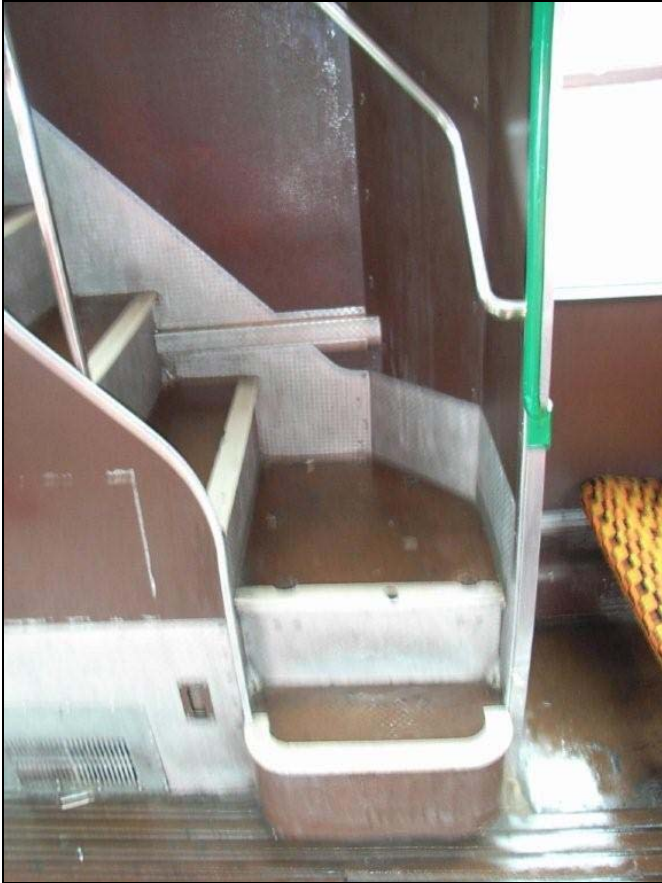
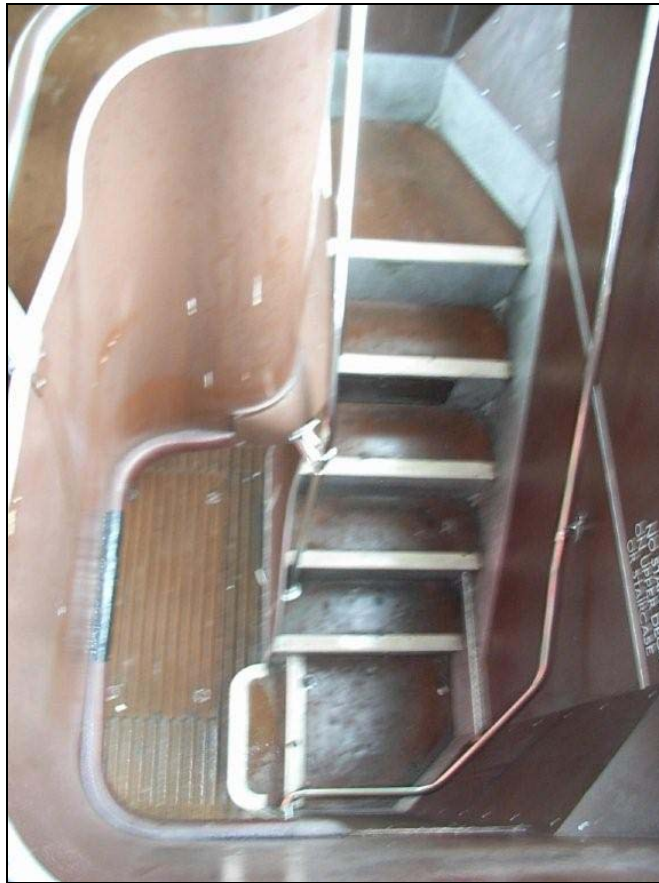
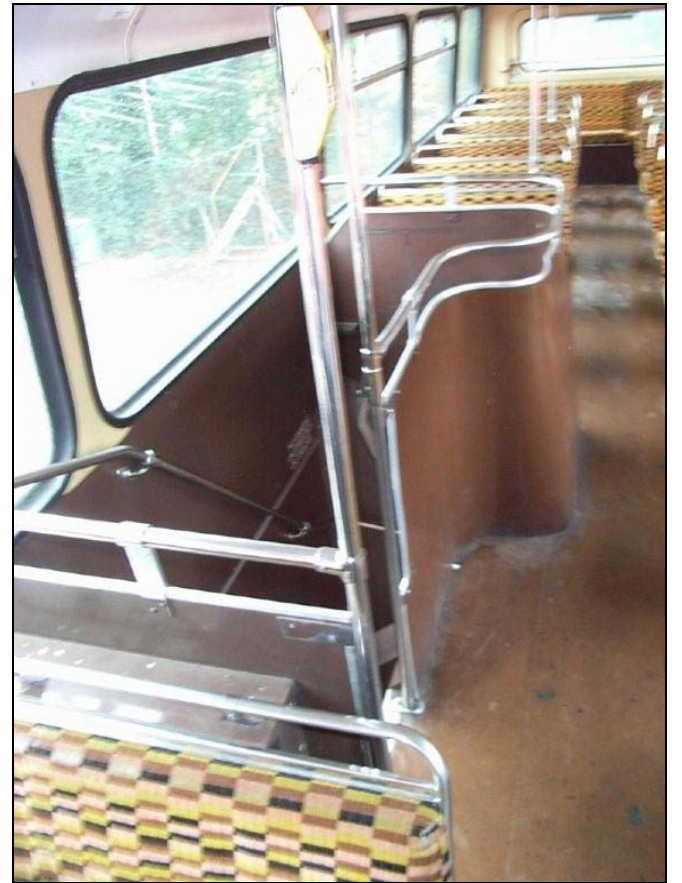
Fig 4 : Metrobus staircase

Like the Routemaster and the DMS, both the Titan and the Metrobus – although also sold elsewhere - were specifically designed for the London market. But from the late 1980s London bought standard “provincial” buses, most of which had spiral staircases. The Metrobus, however, was different (Fig. 4).

The spiral effect was eliminated by squaring off the turns. The price for doing this was that the bottom step protruded into the gangway area of the lower saloon, reducing the width of the route from the entrance at the front to the seats at the back. In practice this was not a problem, because there were no seats opposite the staircase as this was deliberately aligned with the exit doors.

Of the various designs to date, it appears that the square staircase as used on the London Metrobus of the 1980s offers the best solution. It is easy to climb, and the absence of both the long open drop and the narrowed treads at the inner side of a spiral makes it the least difficult to descend.

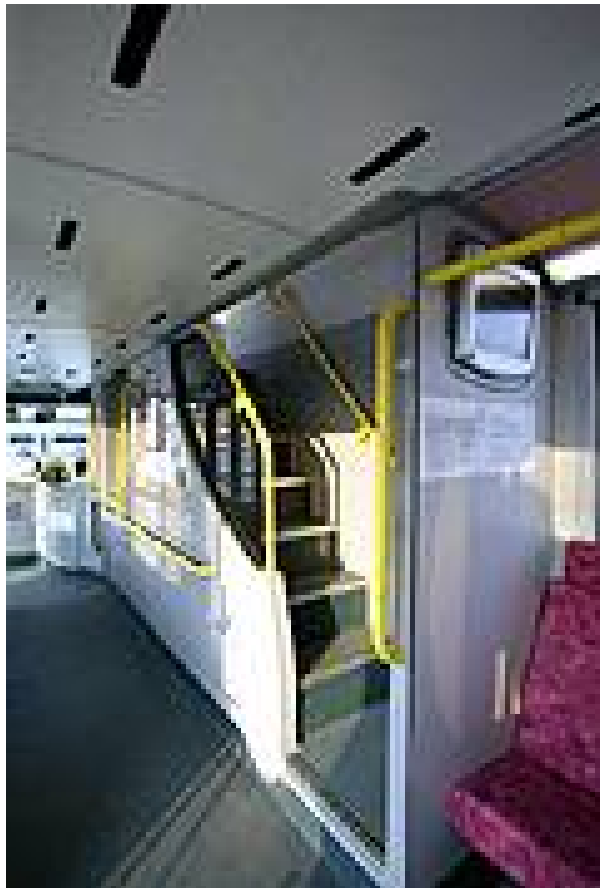
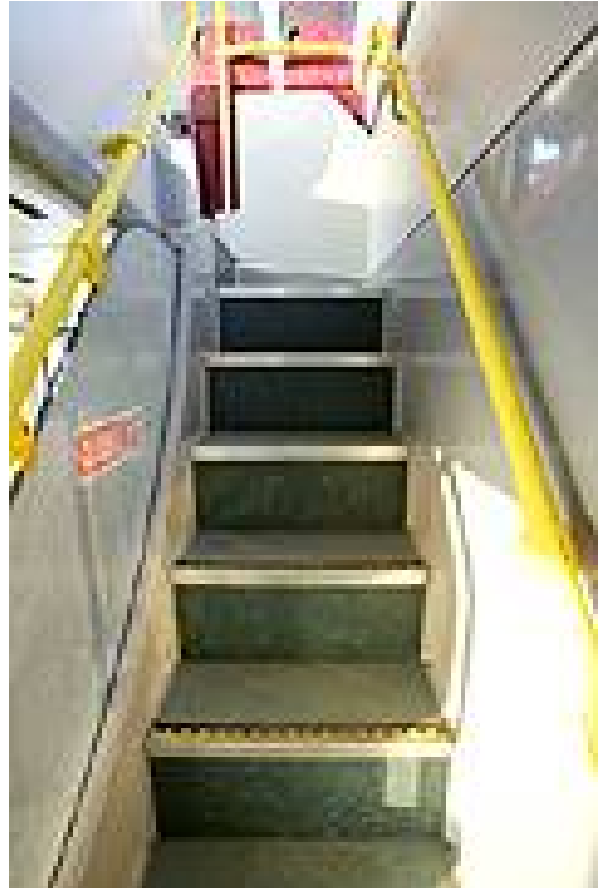
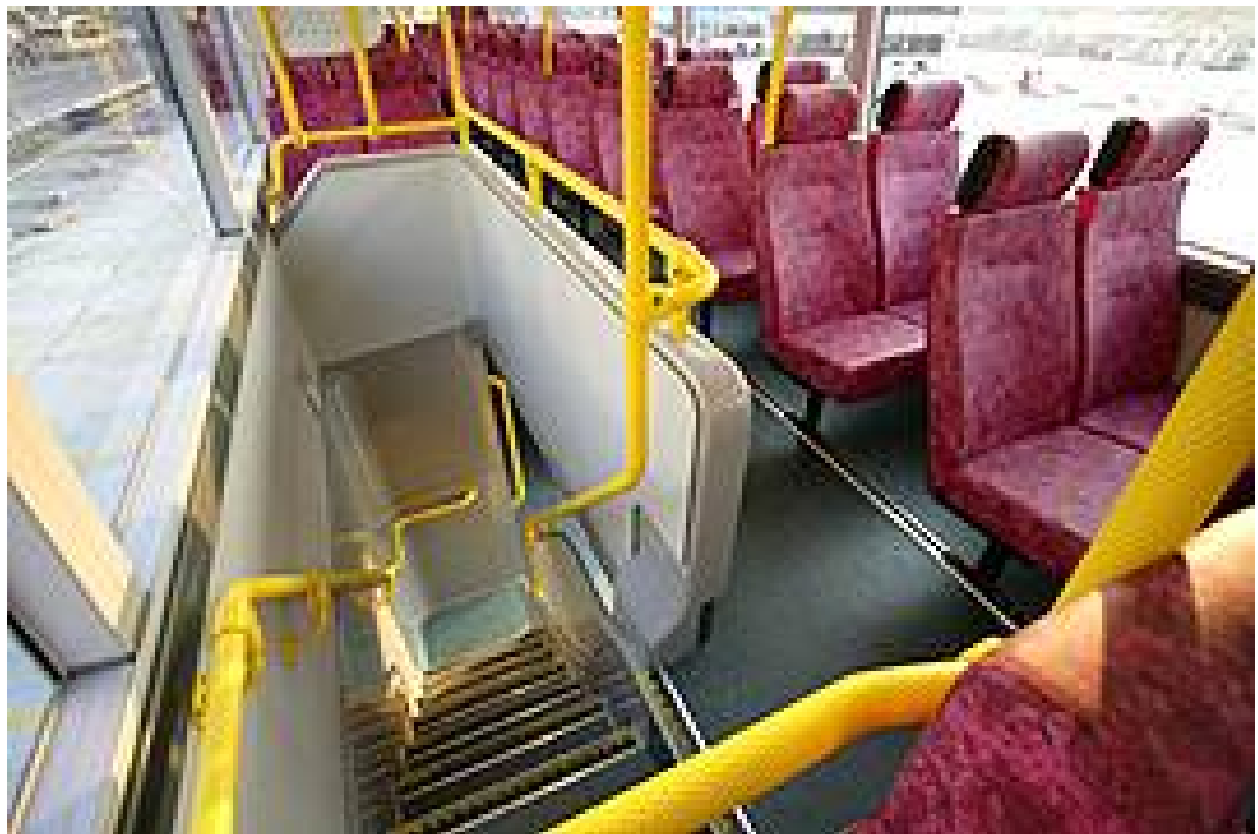
Fig 5 : Straight staircase

Early designs offered many different detailed arrangements for staircase, wheelchair and exit door positions and (prompted by London Buses) some had a new design of staircase – the straight staircase (although this was not actually new, as it had been tried in London in the 1930s and soon abandoned) (Fig 5).

After demonstrating various designs to user representatives, including what is now London TravelWatch – London Buses soon issued a standard specification for staircase, wheelchair and exit door positions. This included a requirement for a straight staircase. Almost all London double-deckers now have straight staircases, the only exceptions being the heritage Routemasters on routes 9 and 15 and possibly a handful of early low floor buses which have not yet been cascaded to non-London operators.

There was little doubt that for people who use the upper deck of a bus (i.e. those with no serious mobility impairment) a straight staircase was easy to climb and – when demonstrated on a stationary vehicle – easy to descend. However they have not been universally adopted, as many non-London operators still specify the spiral design; one reason for this is probably that the spiral occupies less space and therefore allows more seats.

- 2.2.5 For the passenger, the problem with a straight staircase becomes apparent once the bus actually moves. The reality is that a bus lurches about – back and fore, sideways, up and down and in any combination of these – and can brake suddenly. For passengers going up the stairs there is no real problem; if they are thrown off balance the worst that is likely to happen is that they fall forward onto the staircase. This is unpleasant and may result in minor injury, but it is a risk which passengers seem willing to take.

Descending a straight staircase is different. When standing at the top, the passenger looks down on a long open space which offers an unbroken fall if the bus lurches or brakes suddenly. Even for the most able bodied, this is psychologically disturbing, causes most users to hesitate as they descend (thus slowing the unloading of the bus) and is particularly difficult for those who are carrying bags and therefore have only one hand free to hold the handrail.
